Nisqually River 2007

Source to Sink

Nisqually Field Trip Overview

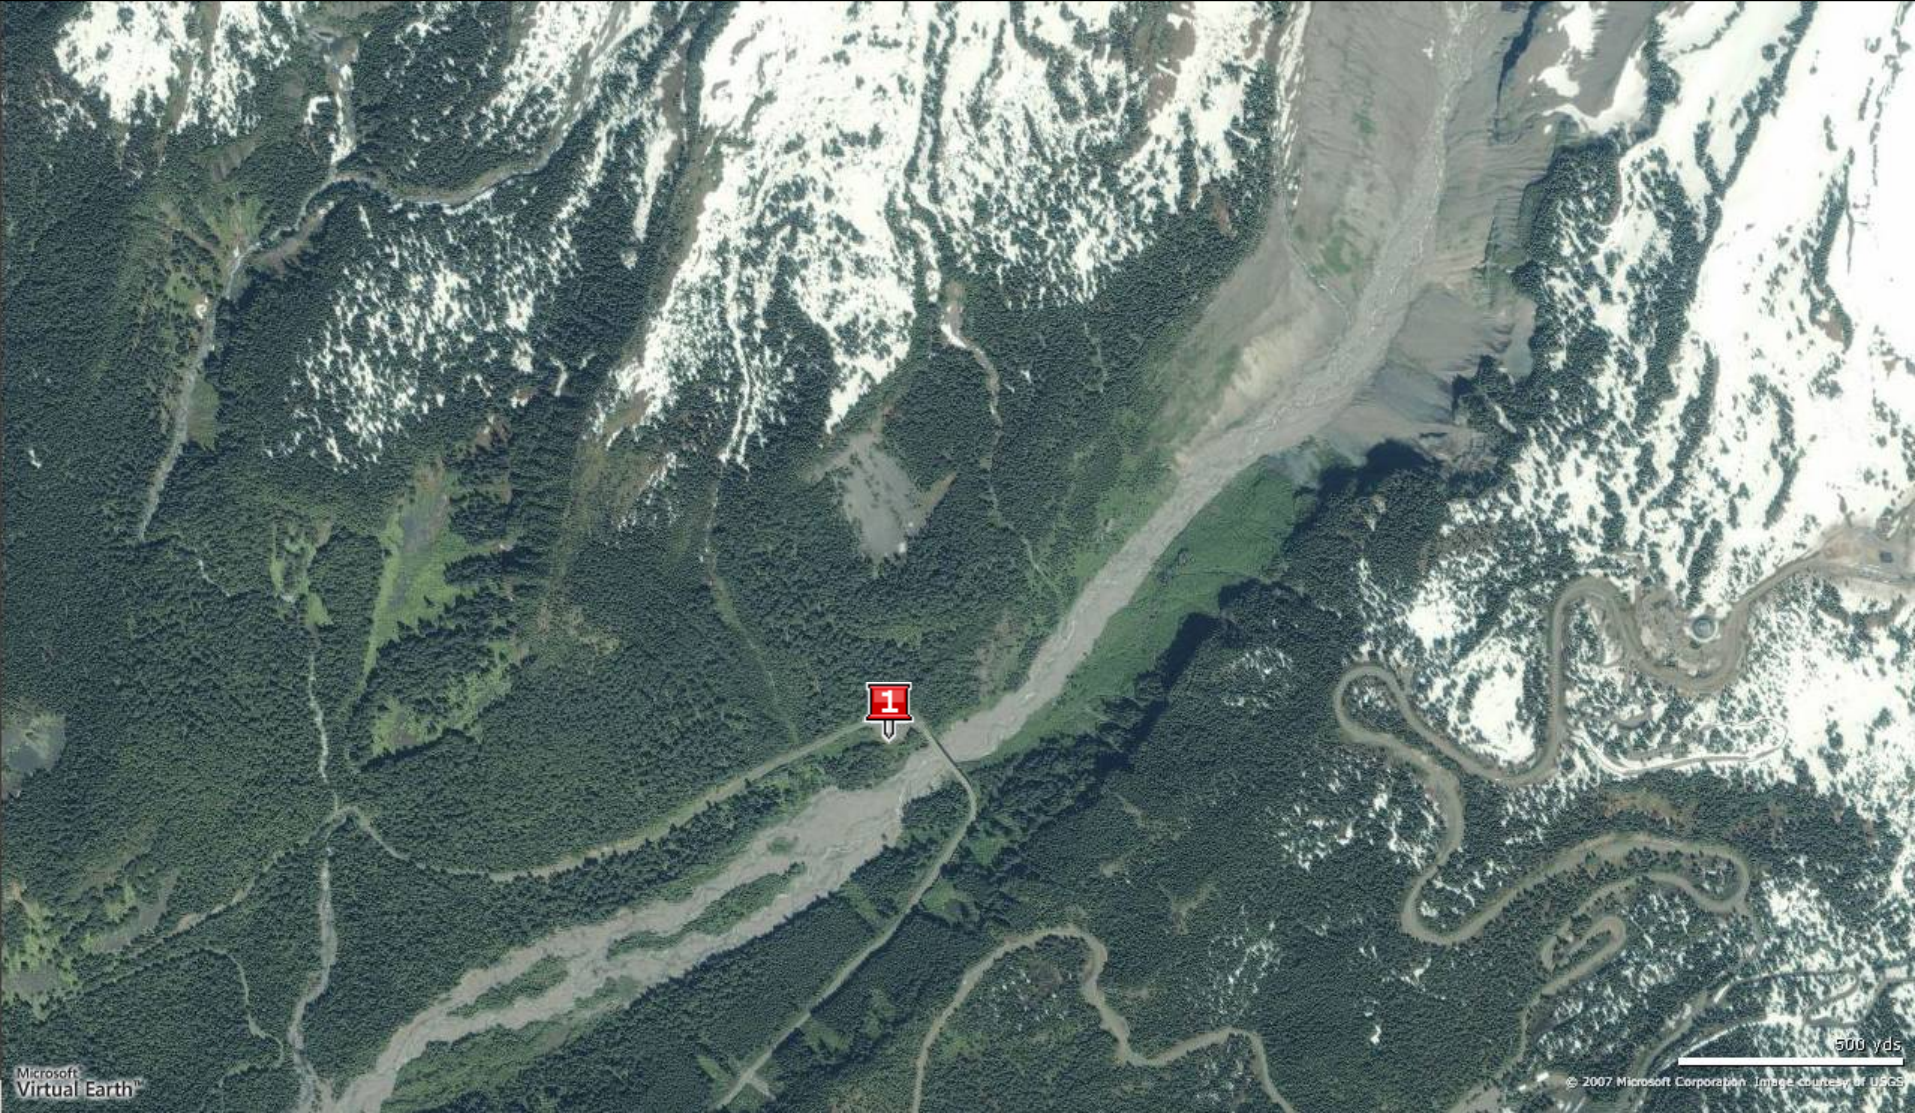
Paradise Rd. Bridge

This is where we will park on a parking lot, and walk over a car bridge with a scary low handrail. It offers a good view up to the barren rocky glacier-clad slopes, and down to the lush forested alluvial valley.

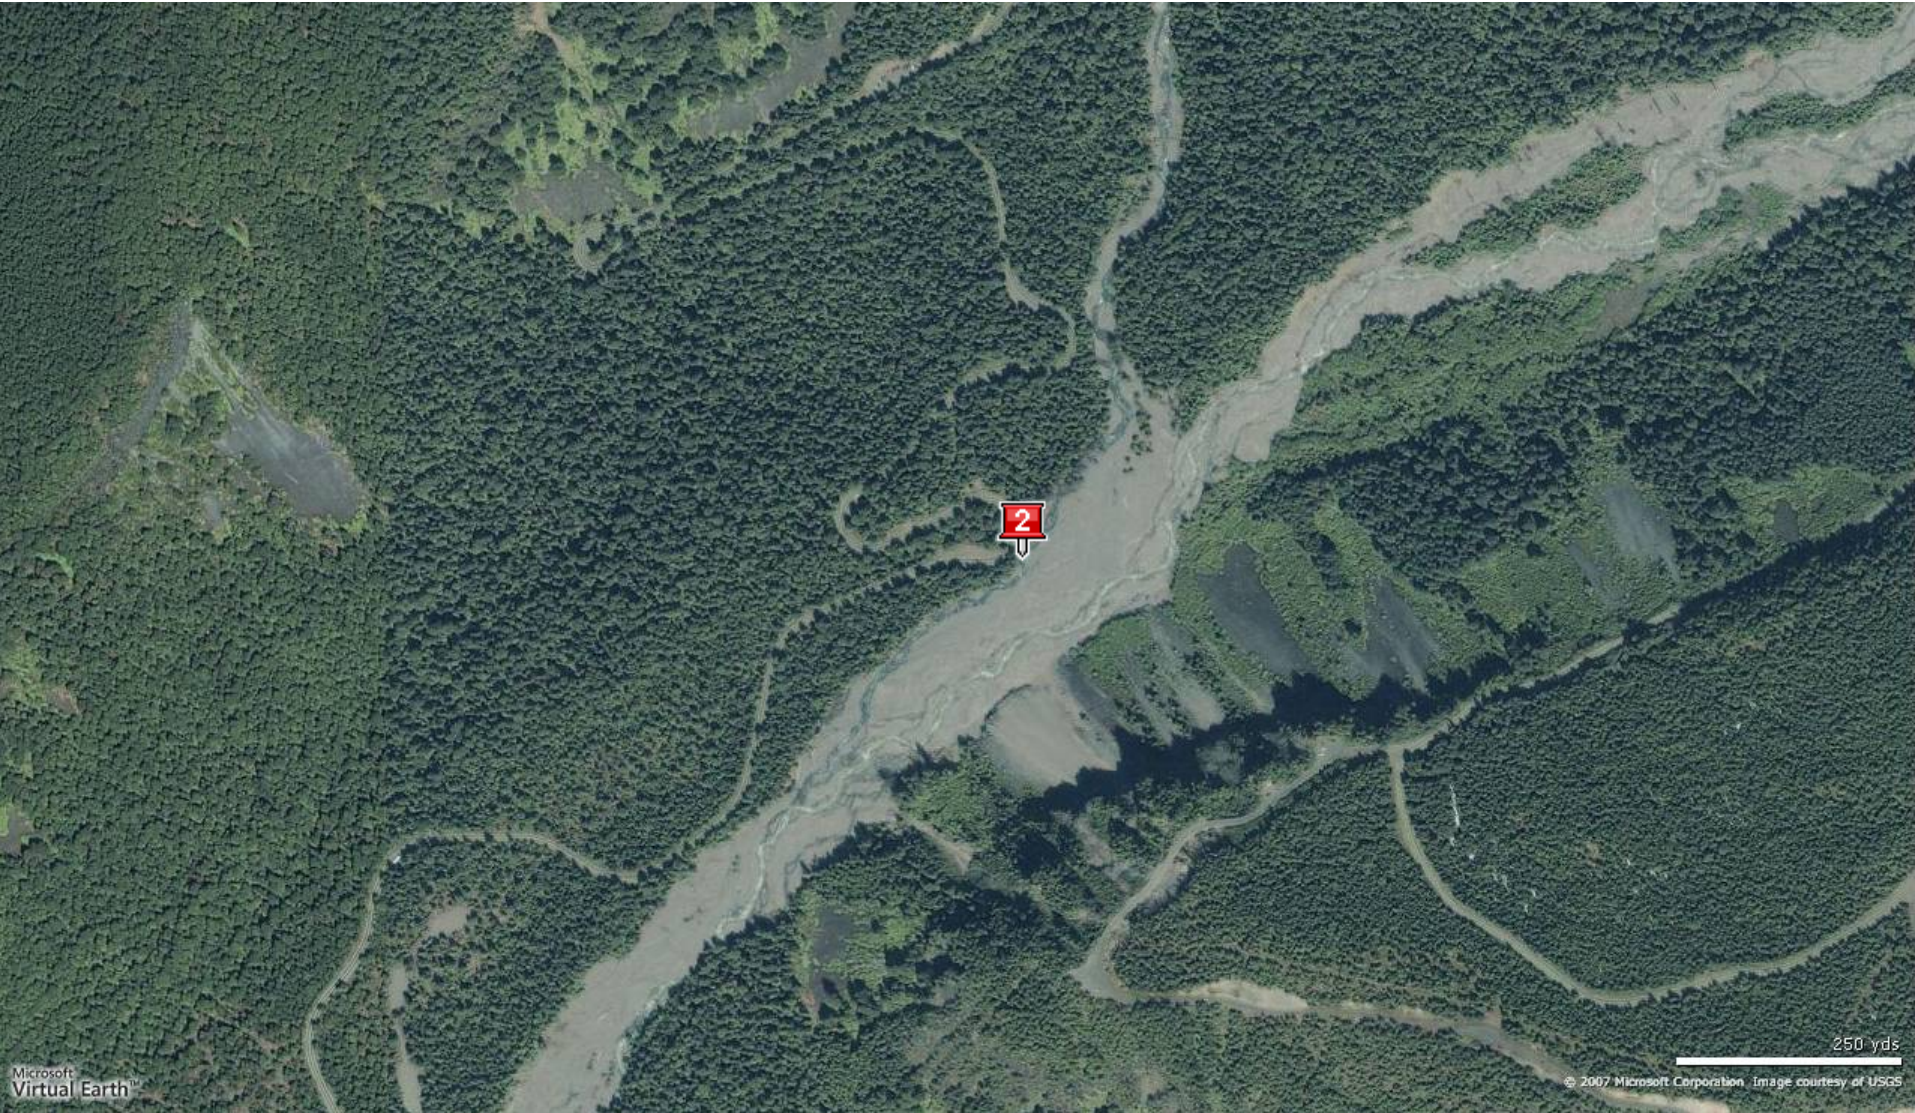
Nisqually@ Abraded Tree

This is a site where wood and river begin to interact. There is demonstration of sediment concentration in the flow, and the erosive power of suspended sediment. Nice boulder and cobble bed and aggraded gravel bars.

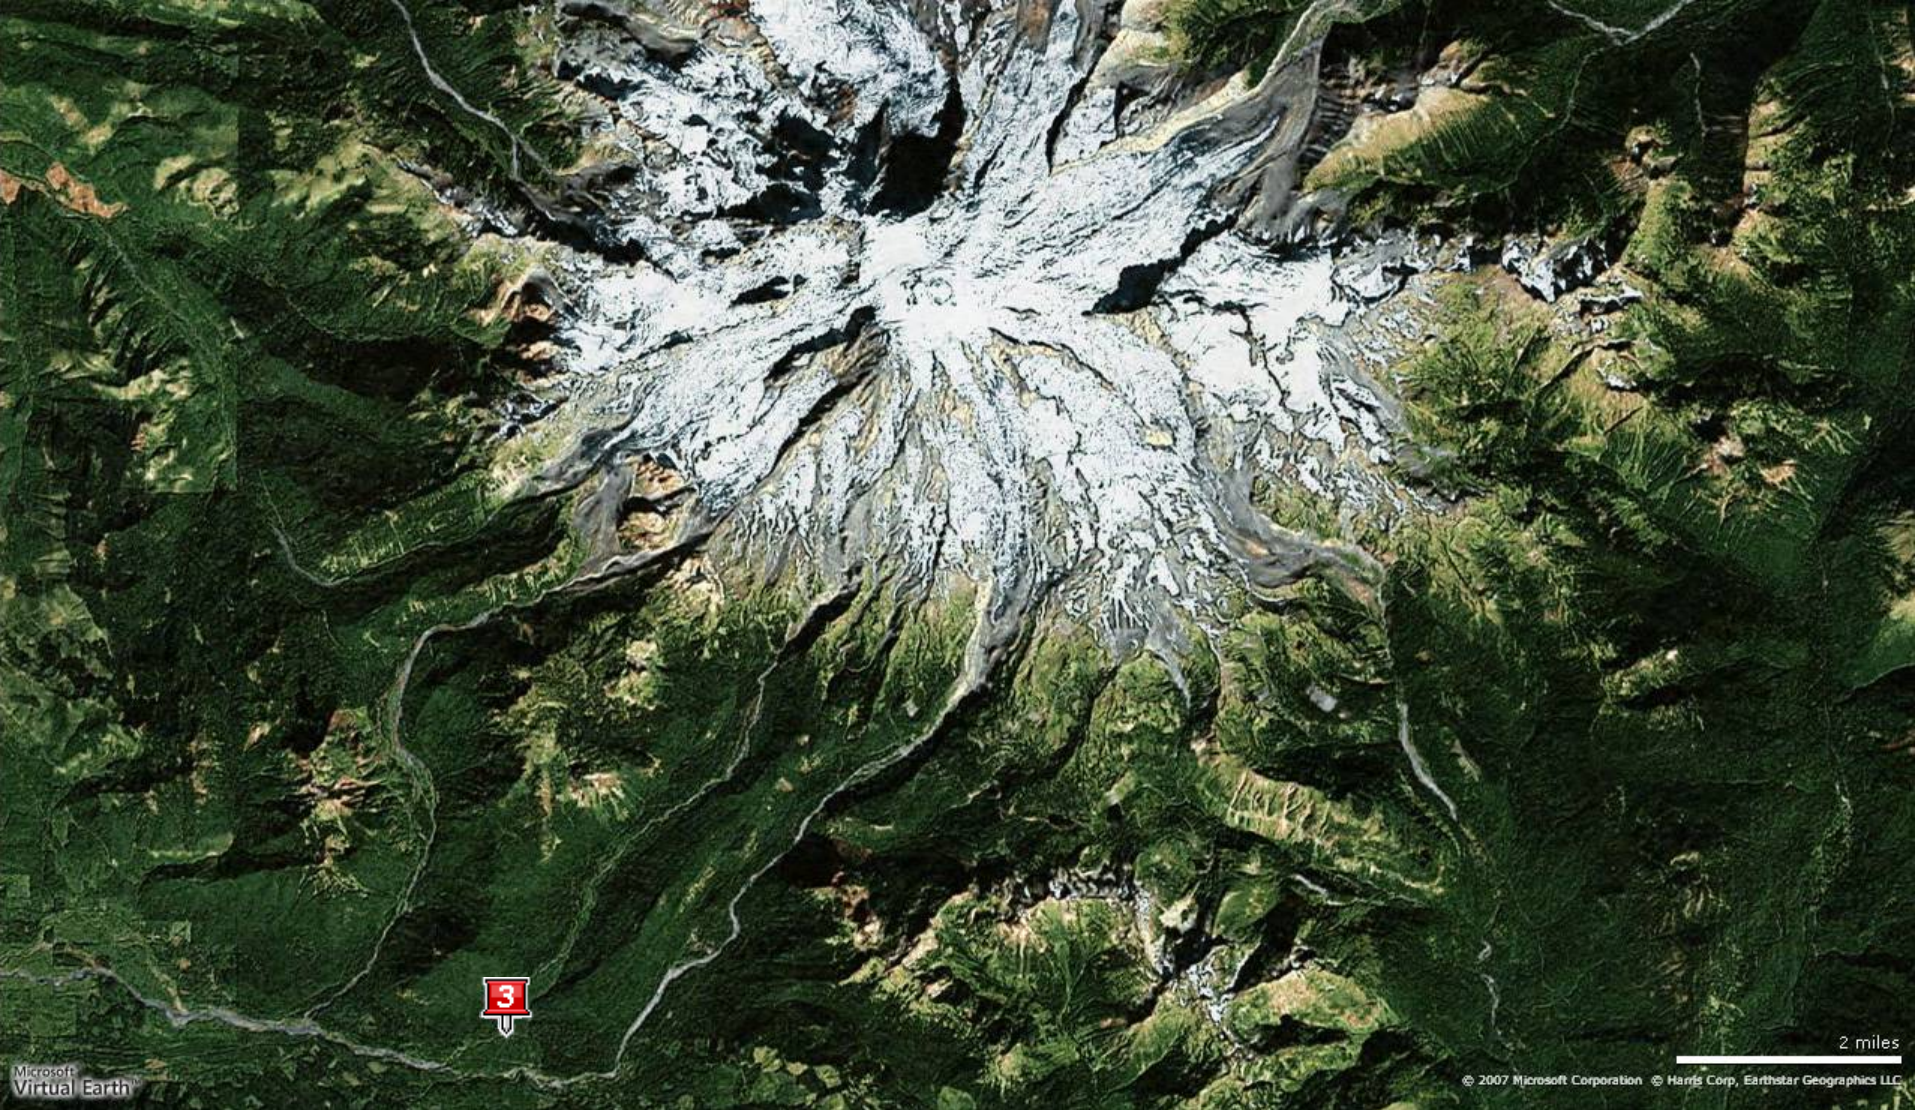
Kautz Creek

The largest debris flow in park history occurred here on 2-3 Oct., 1947. Heavy rain apparently triggered an outburst flood from Kautz Glacier. The flood eroded a gorge through the ice, then transformed into a debris flow continuing downvalley. The road was buried by 9 m of mud and debris. About 40 million cubic meters of sediment were moved, including boulders up to 4 m in diameter.

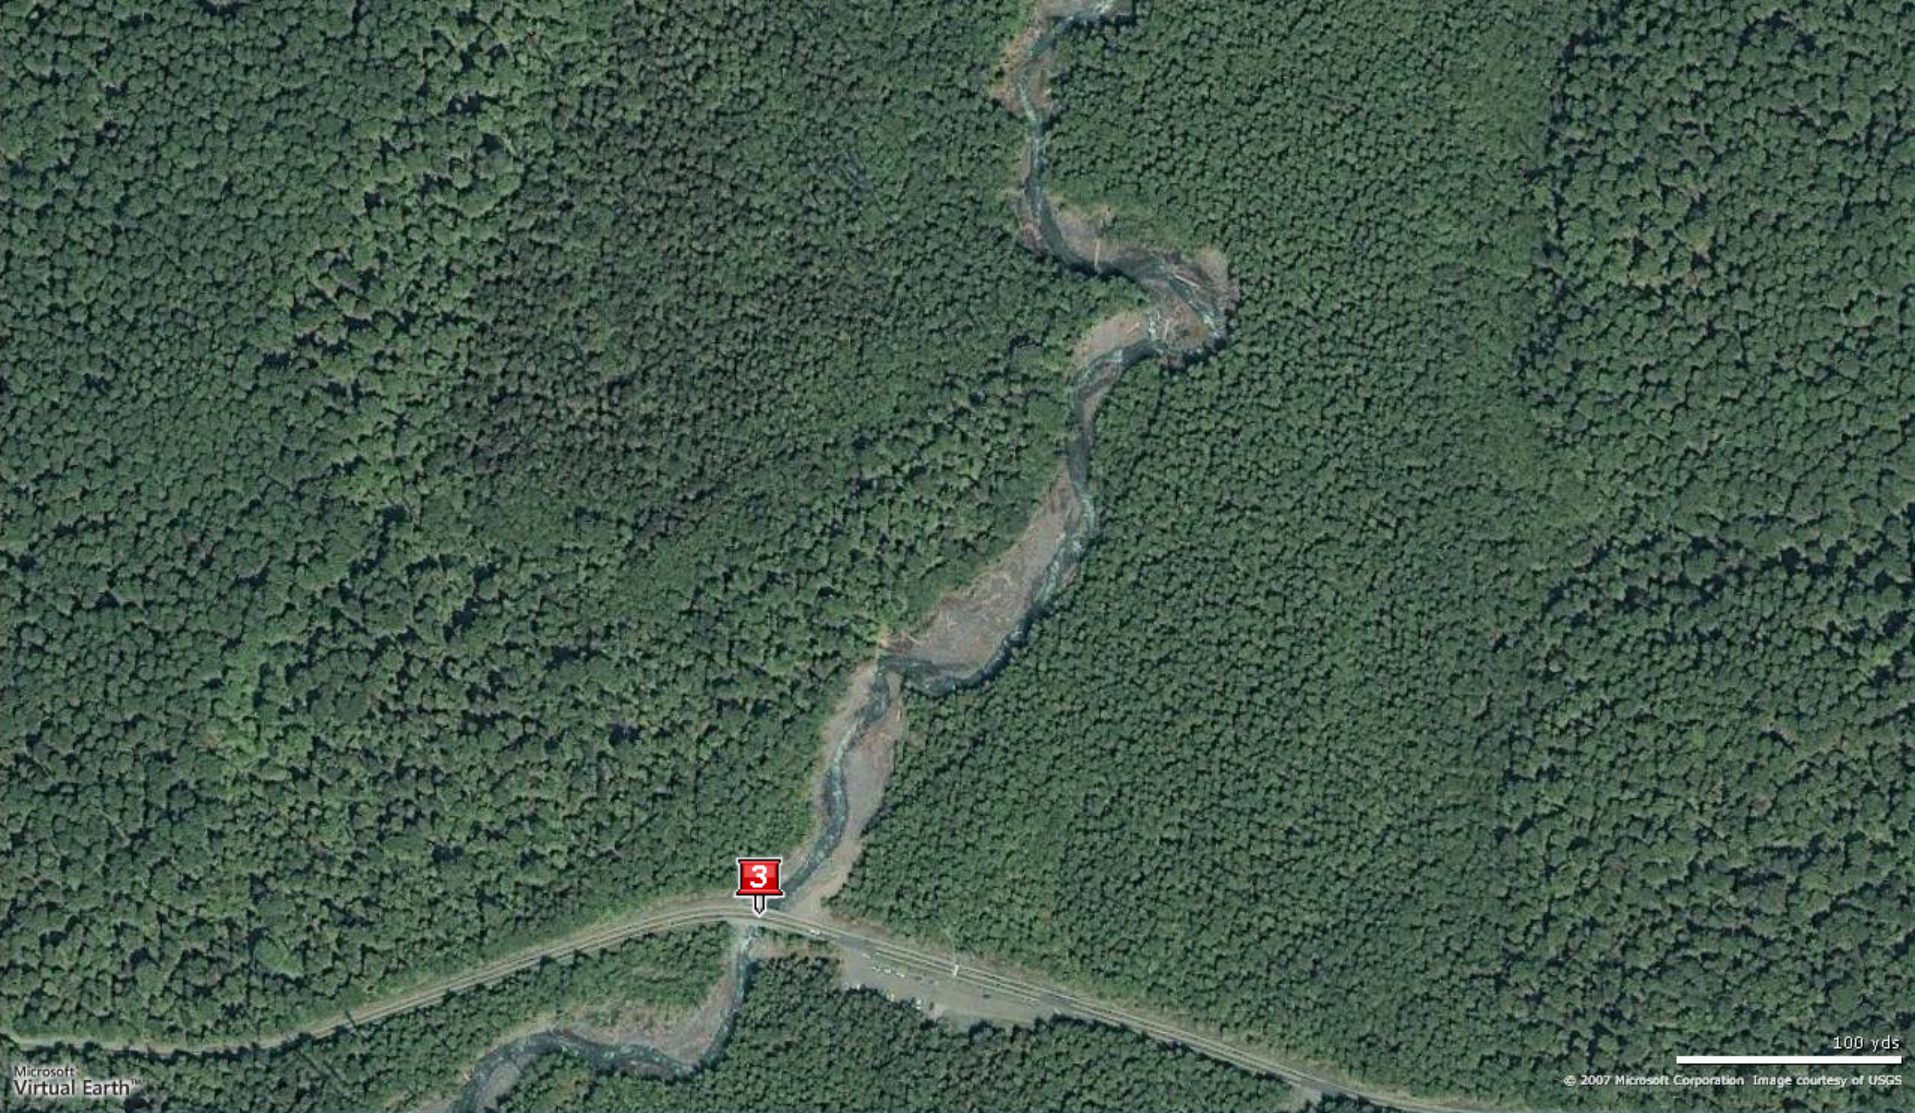
Kautz Creek Bridge

Kautz Creek has cut down through those deposits, but the road approach now goes uphill to the creek. Deposits of the 1947 event can be observed, along with upright dead trees partly buried by those deposits, and scoured out again by later flows . Smaller debris flows have moved along Kautz Creek in 1961, 1985, 1986, and perhaps at other times. ([modified from USGS](#))

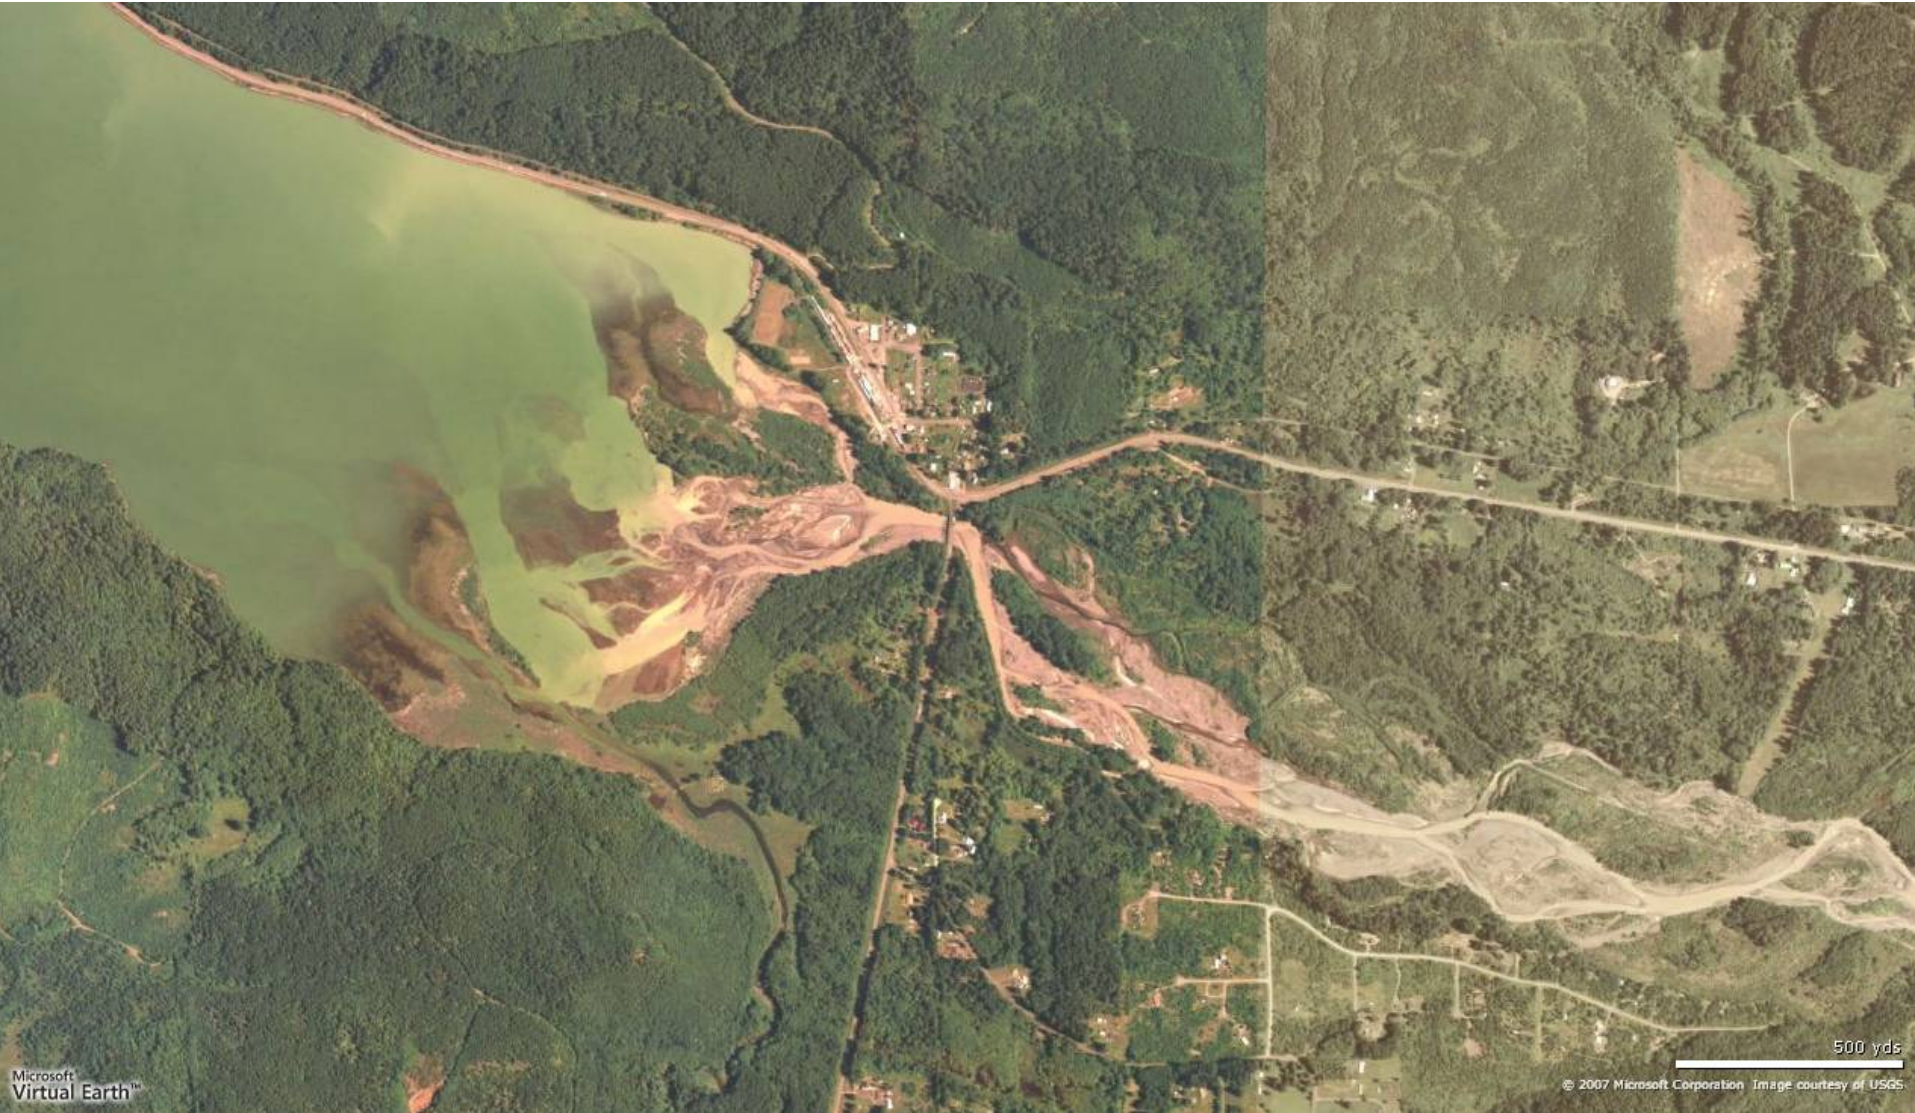
Nisqually river @ Alder lake (Elbe)

The river rapidly deposits sediment at the delta because all but the finest sediment settles into the lake. Note how the channel widens and forms distributaries. These channels rework the sediment as the delta front advances.

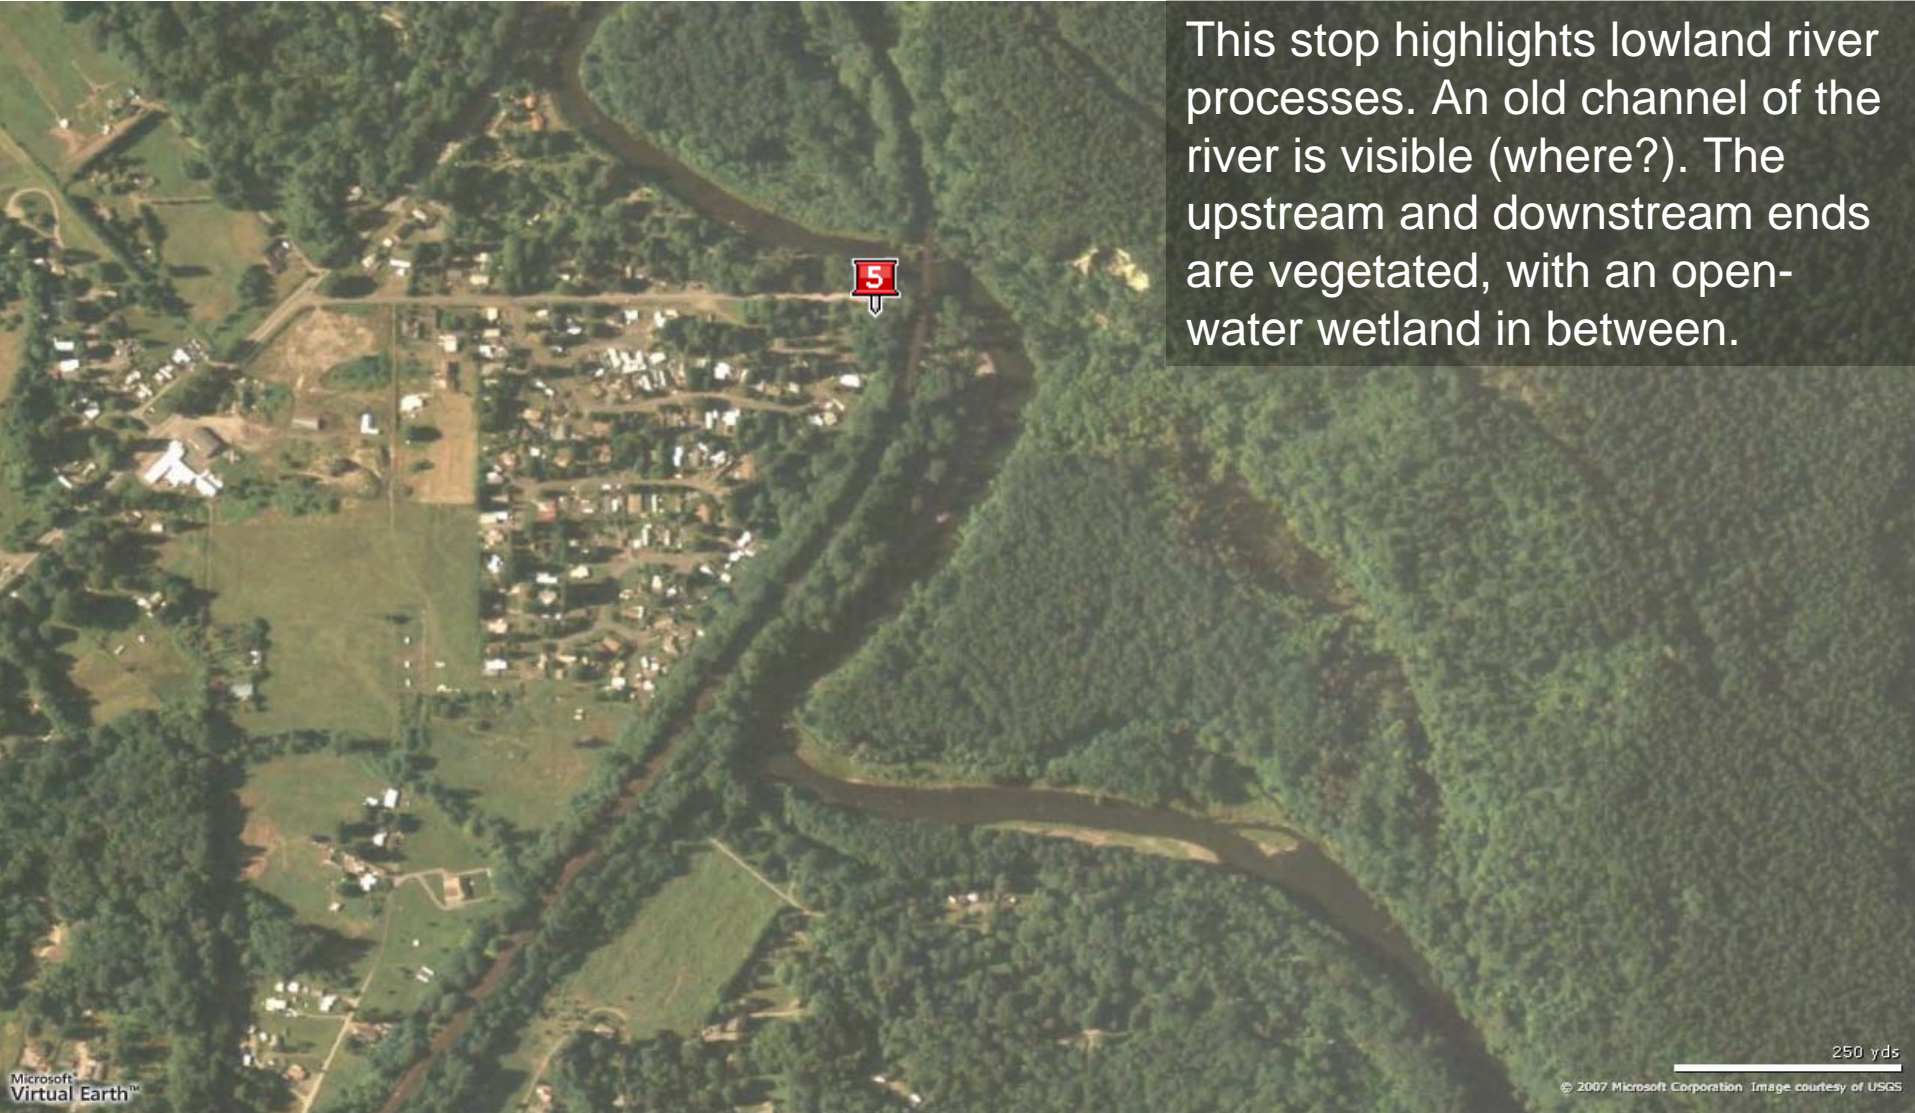
Nisqually @ WDFW HNDTCP

This stop highlights lowland river processes. An old channel of the river is visible (where?). The upstream and downstream ends are vegetated, with an open-water wetland in between.

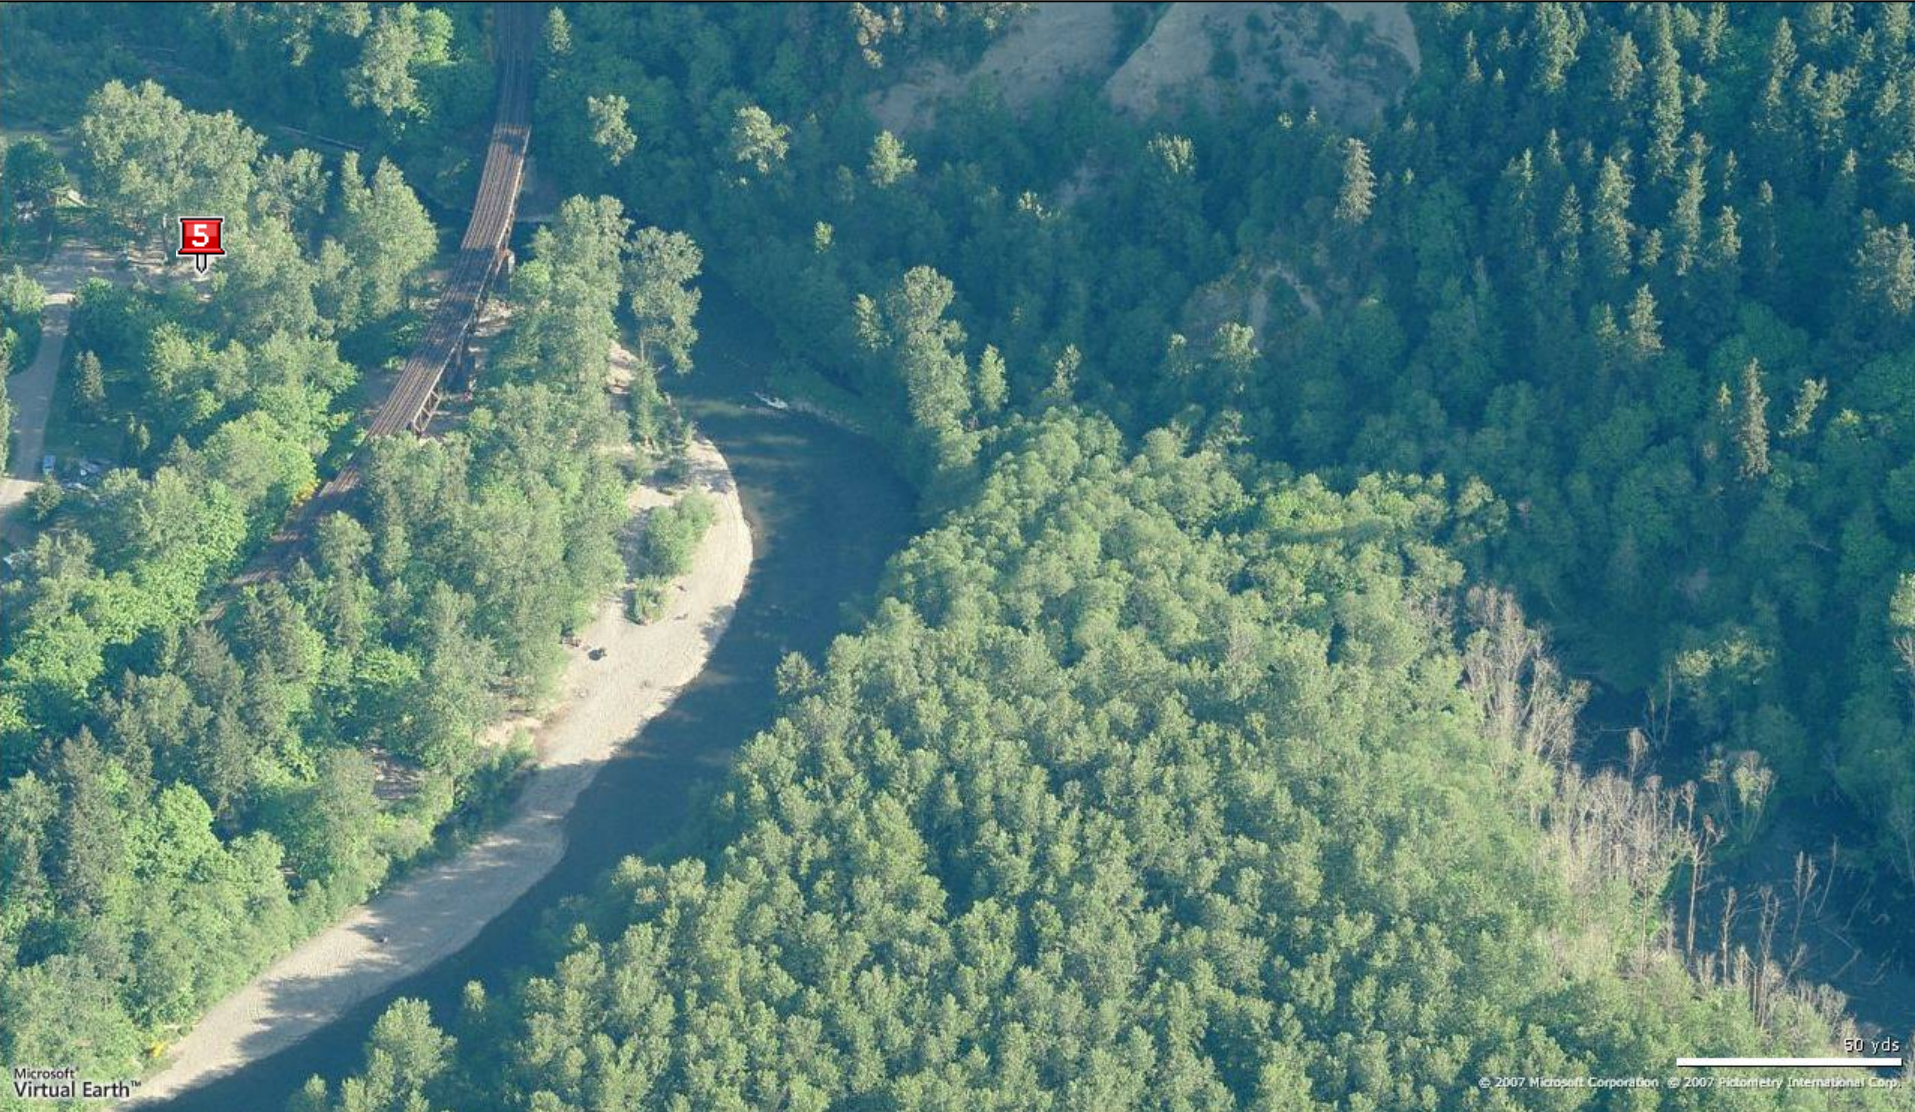
Nisqually River @ Nisqually HNDCCP

This site has a nice gravel bar, and wood is visible on the right bank in aerial imagery. Also the hardwoods on the RB occupy an old side channel that looks like a sweet little coho nursery.

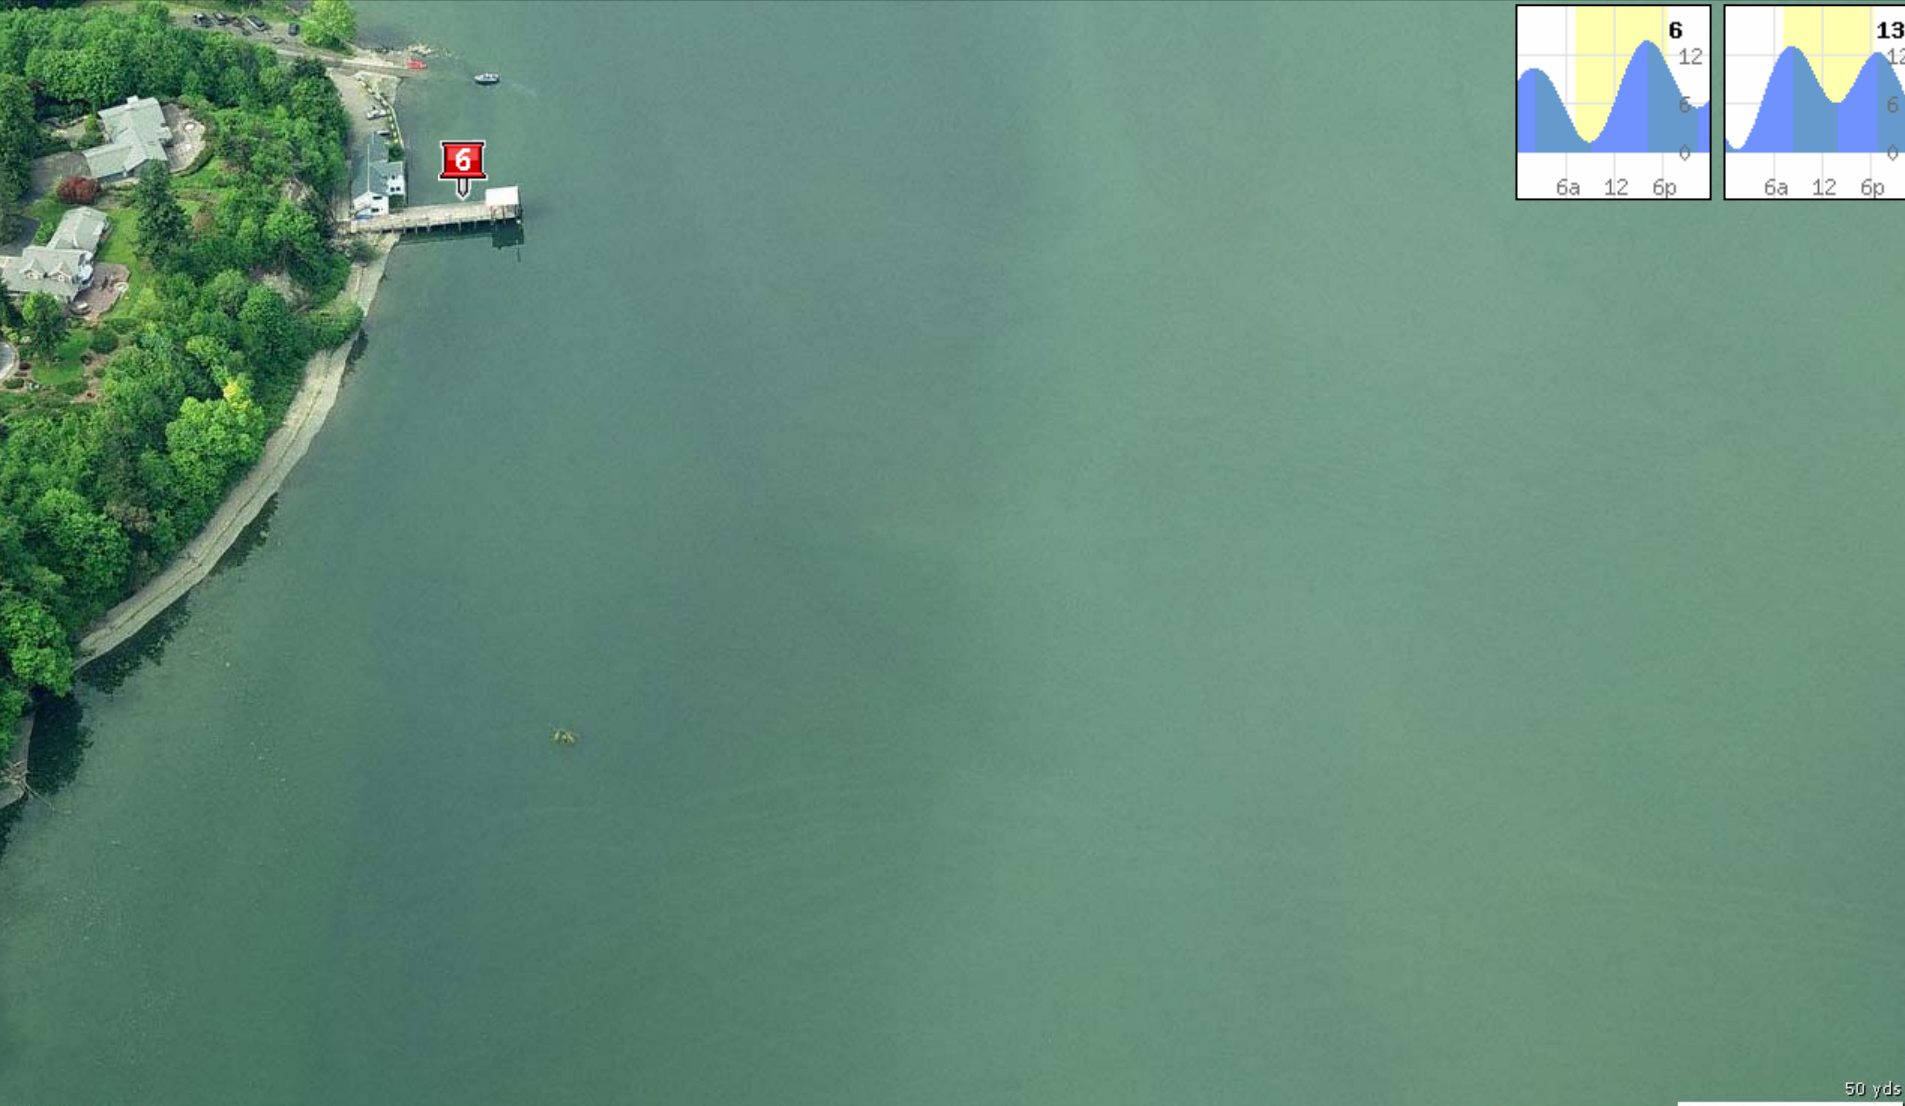
Nisqually Estuary @ Nisqually Nature Ctr.

This is an aerial of the Nature Center at ~high tide.

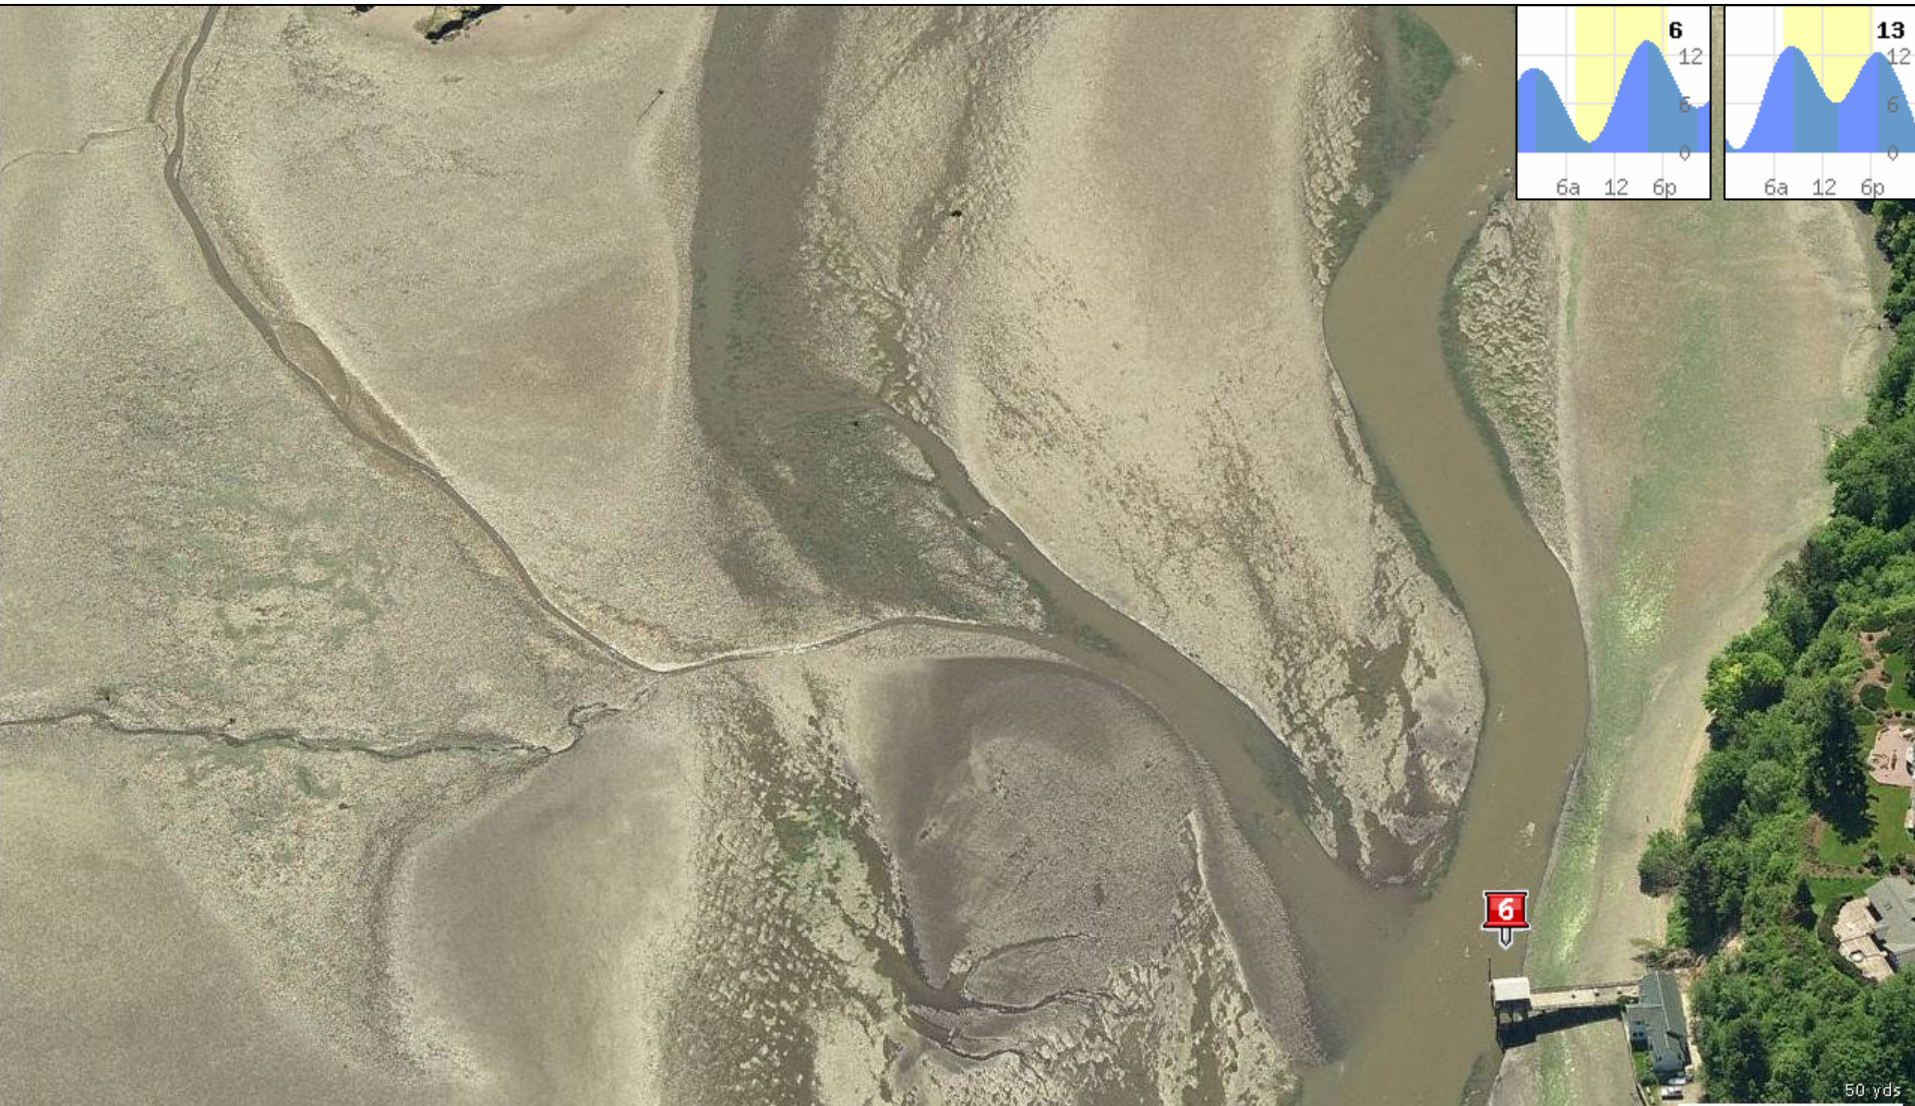
Nisqually Estuary @ Nisqually Nature Ctr.

This is an aerial of the Nature Center at
~low tide.
